Trip Report 2002 Annual Inspection of the Parkersburg, West Virginia, Nuclear Waste Policy Act Section 151(c) Disposal Site

Summary

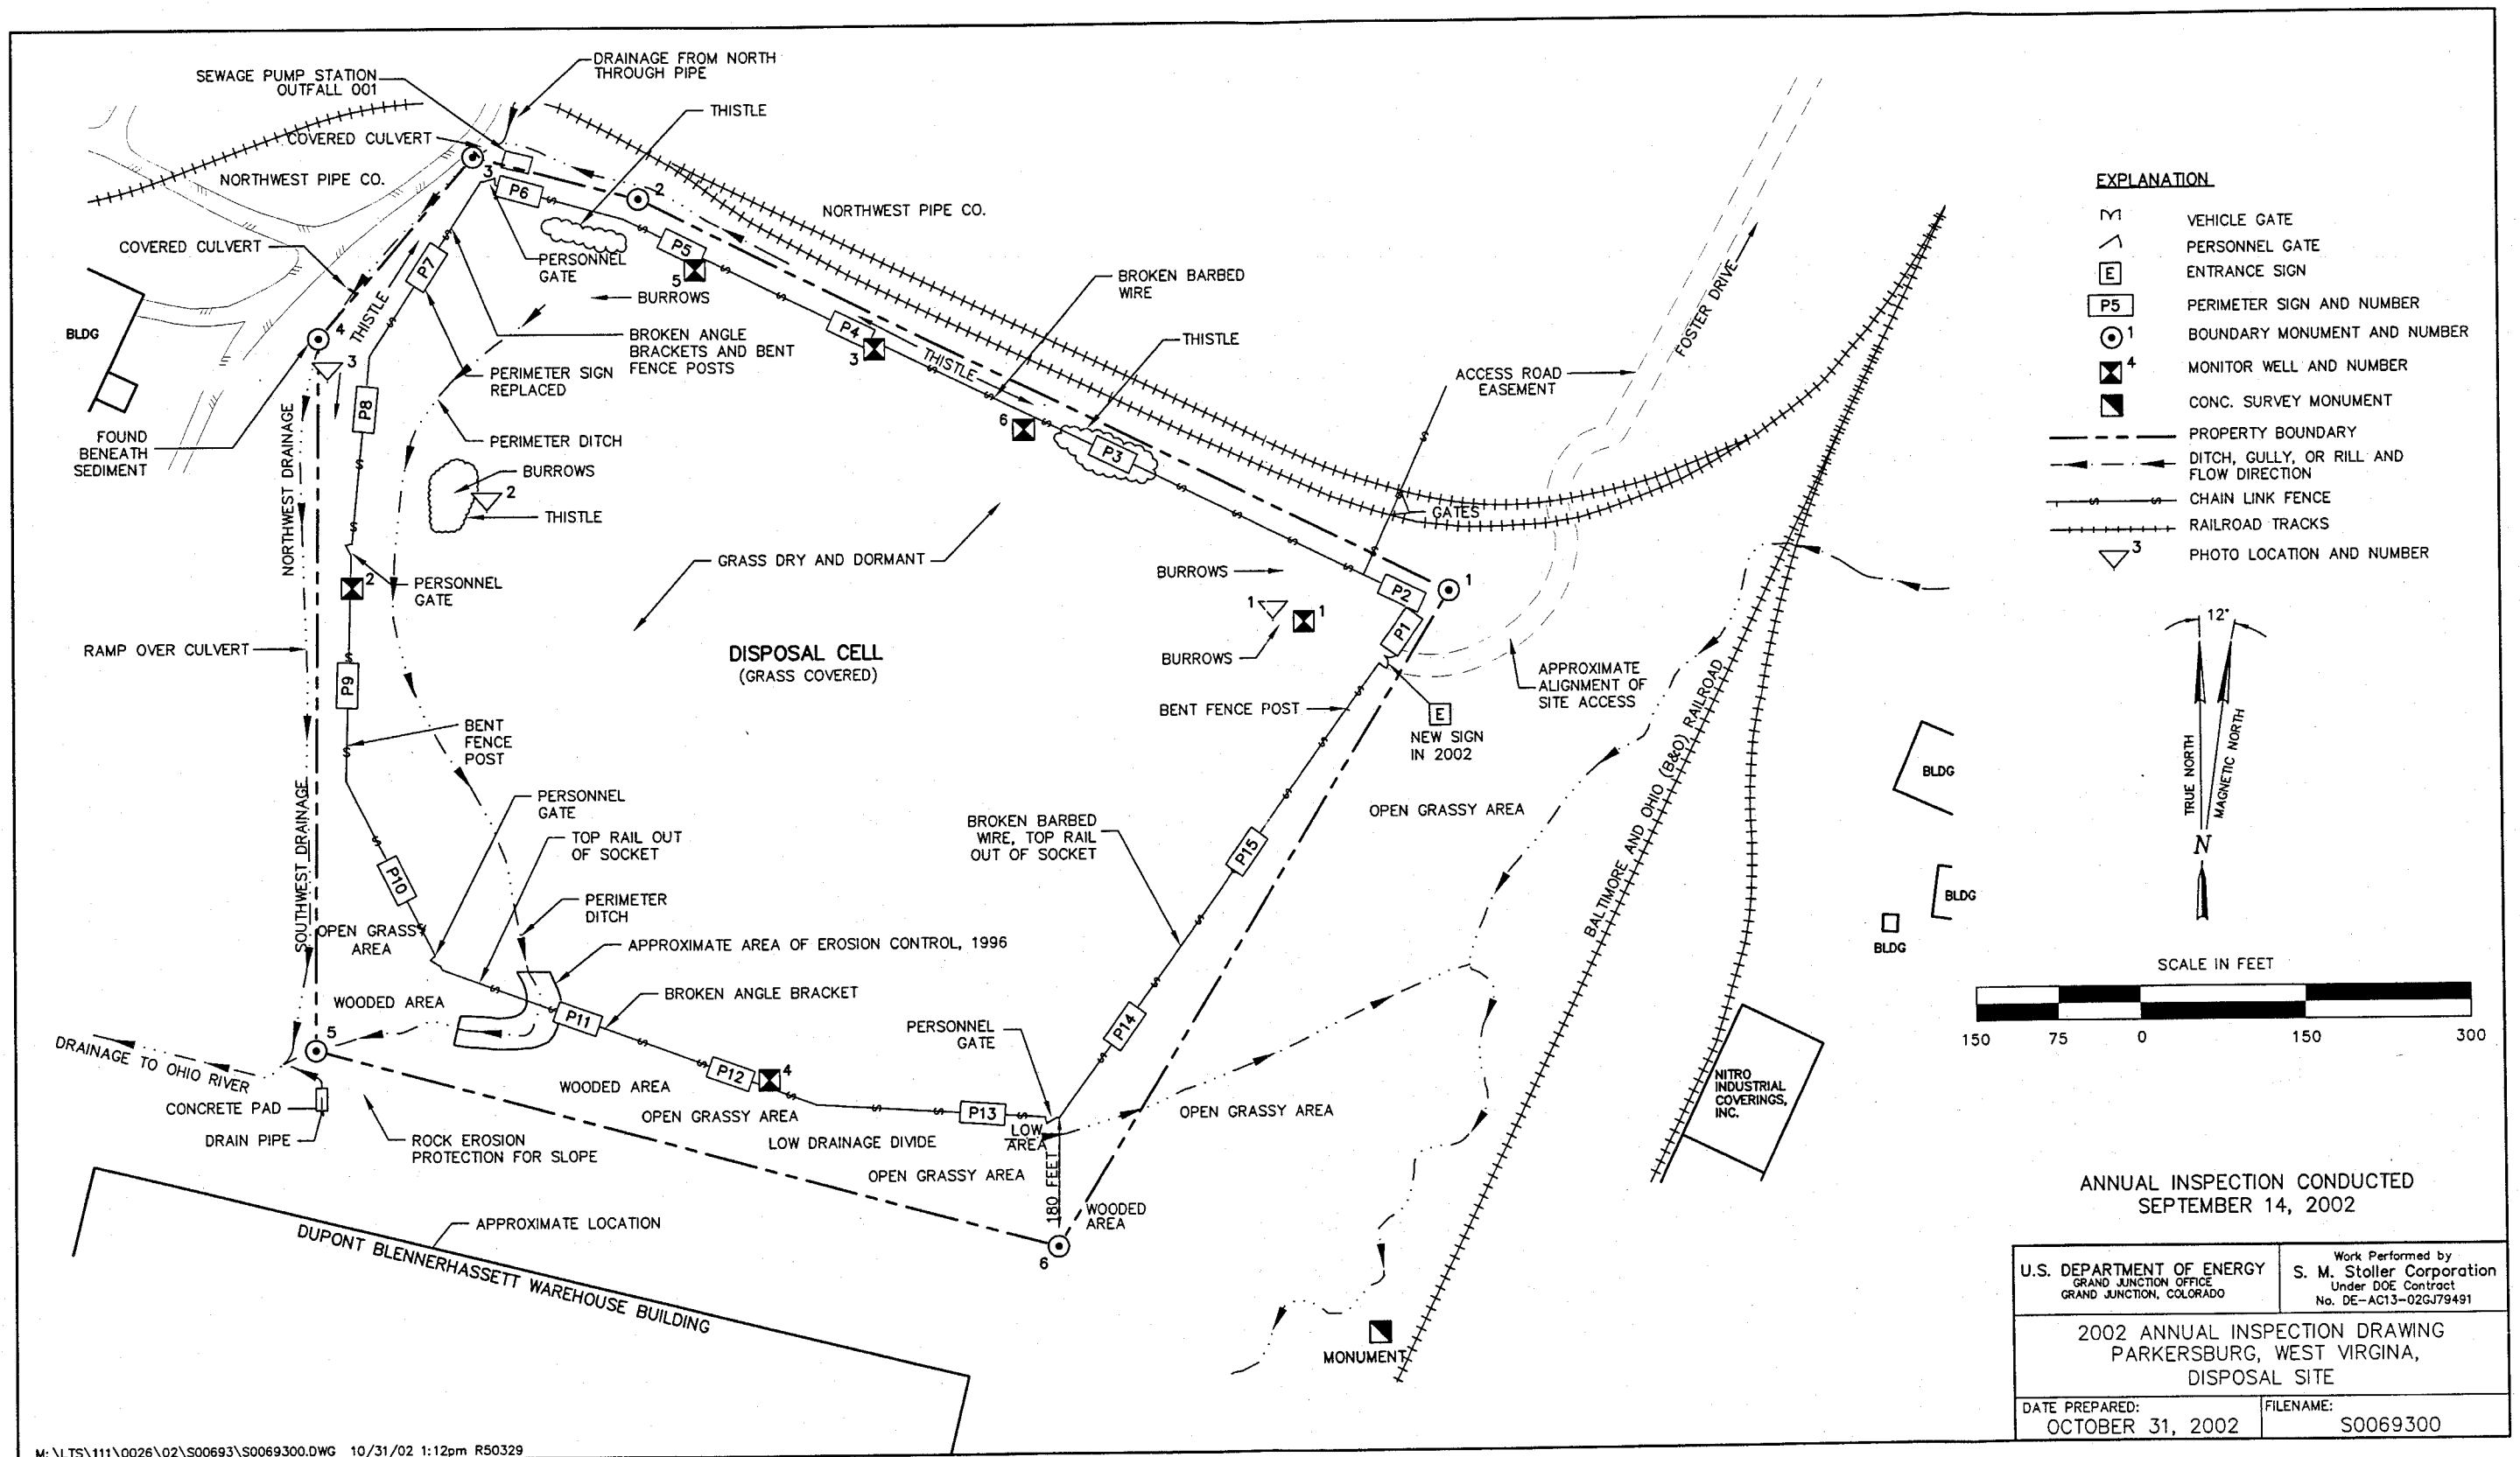
PKB 9/2002. PL-3. Boundary Monument BM-4.

Inspectors could not find boundary monument BM-4 during the 2000 or 2001 site inspections. This monument is located in the bottom of a drainage ditch that parallels the northern property boundary. A local surveyor was retained to locate the monument, replace if missing, and install a reference monument away from the drainage invert. The surveyor found BM-4 covered by more than 4 inches of sediment (PL-3). All other boundary monuments were located and were in excellent condition.

4. Boundary monument BM-4 was found beneath sediment (page 3).

Recommendation: A ground-level reference monument should be installed beyond the drainage invert.
